# ESTCP Cost and Performance Report

(WP-200819)

## Ultrasonic Guided Wave Technology for Non-invasive Assessment of Corrosion-induced Damage in Piping for Pollution Prevention in DOD Fuel Storage Facilities

September 2011

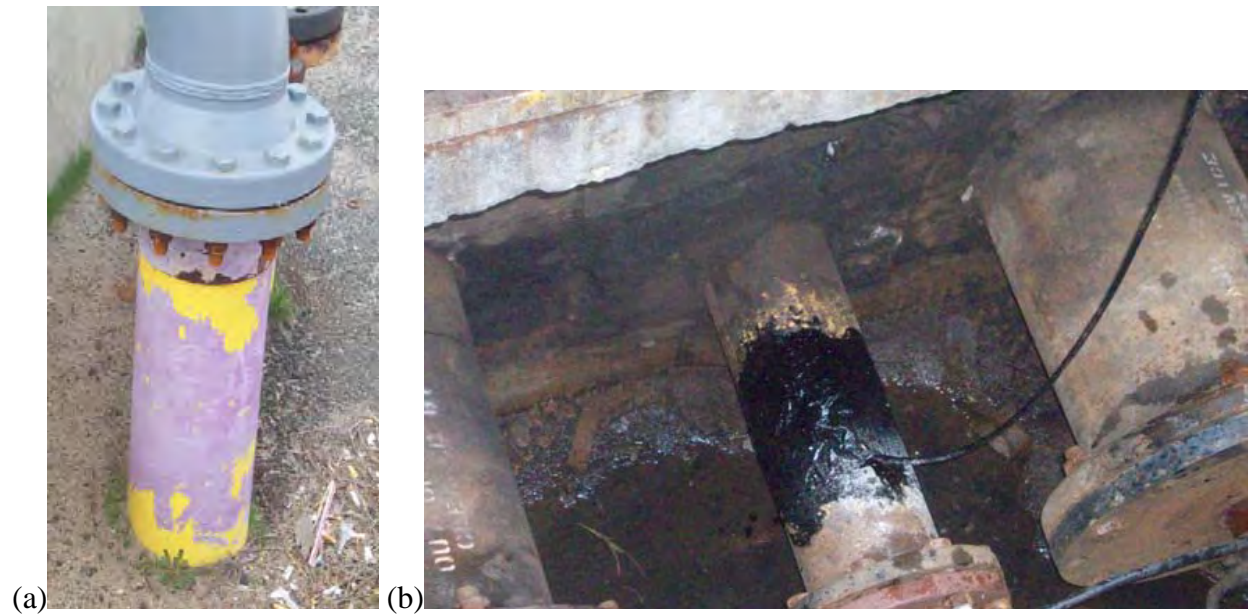
**Figure 6. Surface conditions of tested pipe.**

- (6a) Protective paint on a section of pipe to be removed prior to transducer mounting
- (6b) Protective tar coating and lead wires for a transducer in the underground pipeline

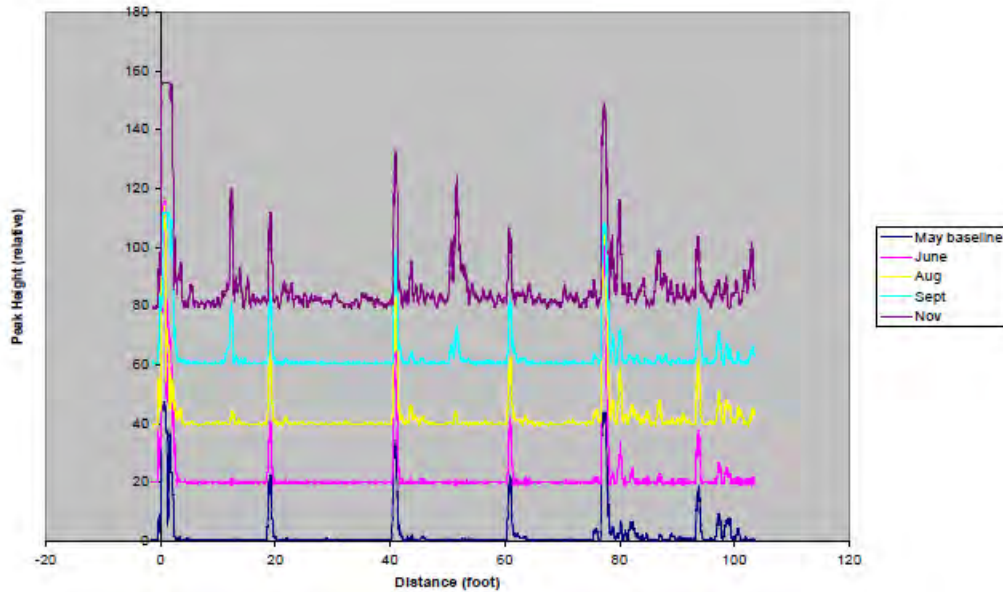
**Figure 9. Systematic increases in defect detection over time as compared to the baseline.**

Shown in Figure 9 is the summary of the aboveground ultrasonic wave data over time as compared to the baseline with a systematic increase in defect peak height with successive stages of corrosion from a transducer placed at location 2. Waves from one transducer detect the presence of welds, elbows, and one or more defects in the guided wave propagation path. As expected, the signal height depends on the size of the defect, the distance between the transducer and the defect, and the number of welds in the wave propagation path. We note that the noise level increased in the later months as corrosion progressed but was less than 0.1 of the weld signal height at about 80 ft.

Systematic increases in peak heights for growing Defects 1 and 2 sensed by transducer at location 2. Defect 1 was located at approximately 50 ft, and Defect 2 was located at approximately 12 ft. The other large peaks, approximately 20 ft apart, are from the welds in the pipeline. The baseline signal (May 2008) is blue, the June signal is pink, the August signal is yellow, the September signal is light blue, and the November signal is purple. An offset of 20 units along the vertical axis has been added to each successive trace before plotting.

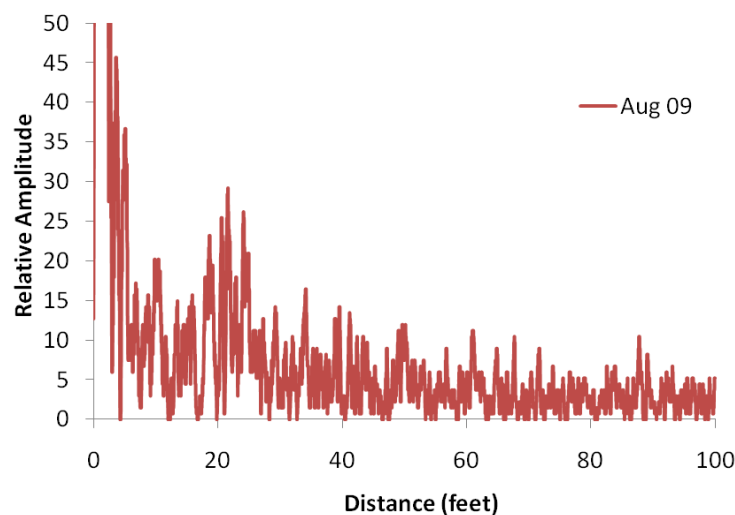
**Figure 11. Signal trace at baseline obtained by sensor #22532 inside VP 21 propagating guided waves towards BL 20.**

Shown in Figure 11 is the baseline trace for wave propagation from VP 21 towards BL 20. The peaks located up to 20 ft represent signals, first from the leakage of the transducer excitation, followed successively by the signals at the wall interface, and from welds and reducers along the pipeline. Of note is the pair of peaks above noise level at about 90 ft, which could be identified to originate from the region on the ground where pipe repair and replacement were made a few years back. The height of these two peaks was approximately twice as large as the noise level, which was four times as large as that typically observed in the laboratory tests in Phase I.

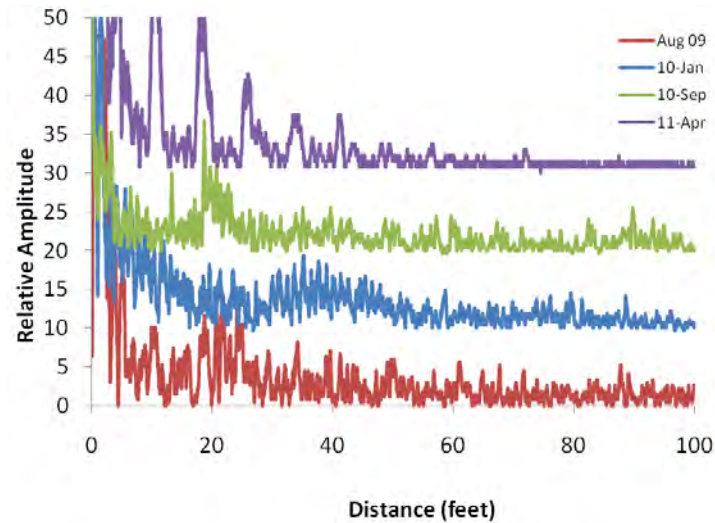
**Figure 12. Monitoring changes in data sets obtained at the baseline and successive months by underground sensor #22532.**

An offset of 10 units along the vertical axis has been added to each successive trace before plotting.

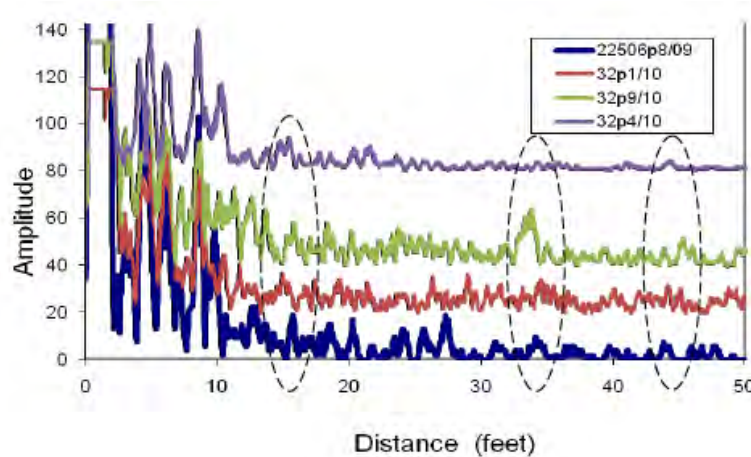
**Figure 13. Monitoring signal changes in data sets obtained by aboveground sensor #22506.**  
An offset of 20 units along the vertical axis has been added to each successive trace before plotting.

Data traces in Figure 13 are for waves propagating from VP 5 towards VP 20 from sensor #22506. Focusing on the groups of peaks around 16 ft, 35 ft, and 44 ft, we observe that the

normalized peak heights at some locations (e.g., 35 ft) have not been increasing consistently or they remained relatively unchanged over the course of the monitoring effort. The locations where peak heights remained constant most likely originated from static structural features such as welds. Inconsistent changes in peak heights could be due to signal noise and/or multiple reflections unrelated to defects.

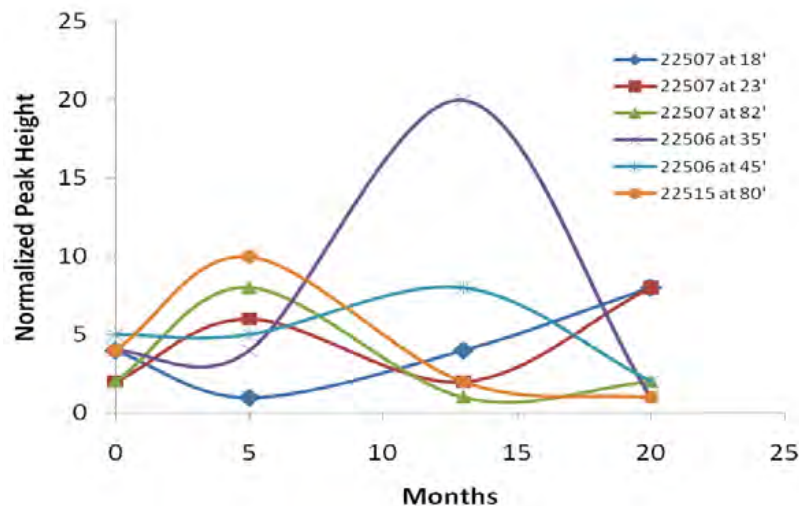
**Figure 14. Changes in normalized peak height at suspected defect locations detected by three aboveground transducers.**

The results of the experiment in Phase I are shown in Figure 14. We observed that none of these peaks increased systematically in amplitude during the 20 months of monitoring. Thus, further monitoring is required to determine whether these locations have corrosion-induced defect growth.

Typical signal noise was two vertical units.
